# **B** APPENDIX B: STRUCTURES AND BUILDINGS AT LONG VALLEY FARM and ASSESSMENT OF EXISTING STRUCTURES AT LONG VALLEY FARM

## **ASSESSMENT OF EXISTING STRUCTURES**

### **at Long Valley Farm**

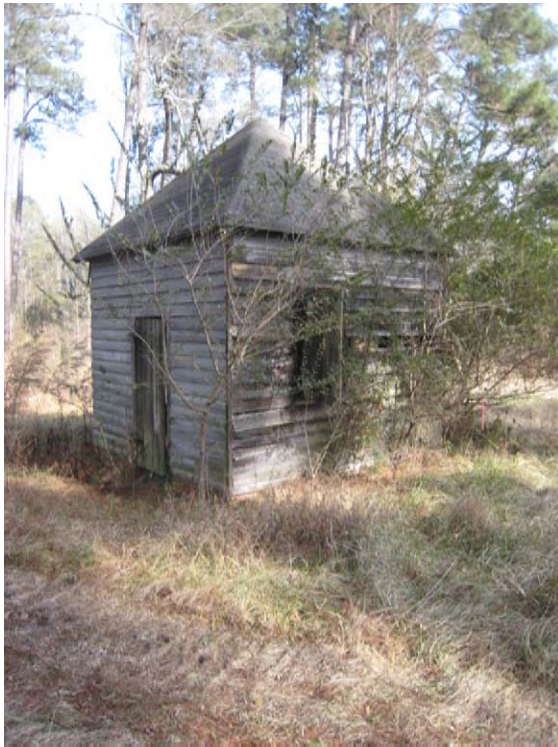
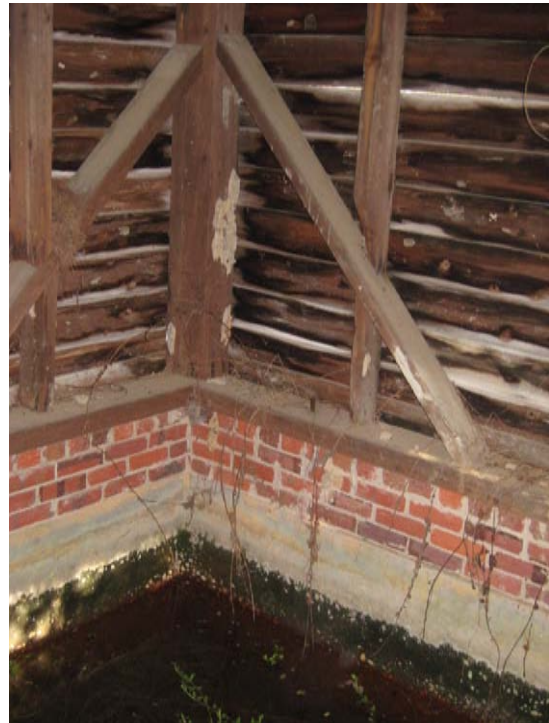
## 2. SPRINGHOUSE

**Foundation System:** concrete footing, masonry apron  
Condition: fair  
Notes: overgrowth on both inside and outside

**Cladding System:** 2x6 horizontal wood lap board  
Condition: poor  
Notes: significant siding pull-out and rot, corner boards need replacing

**FCAP Recommendation:** drain water from concrete box, install cover; reattach and replace siding; trim back vegetation outside and inside

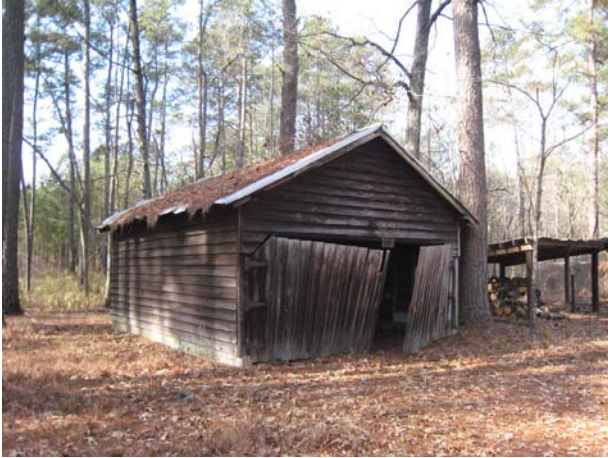
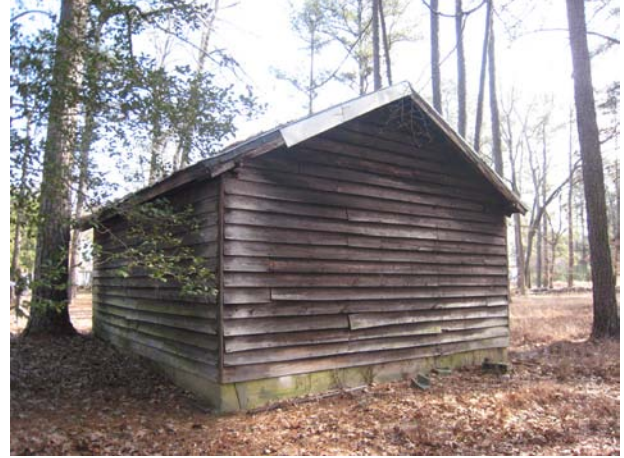
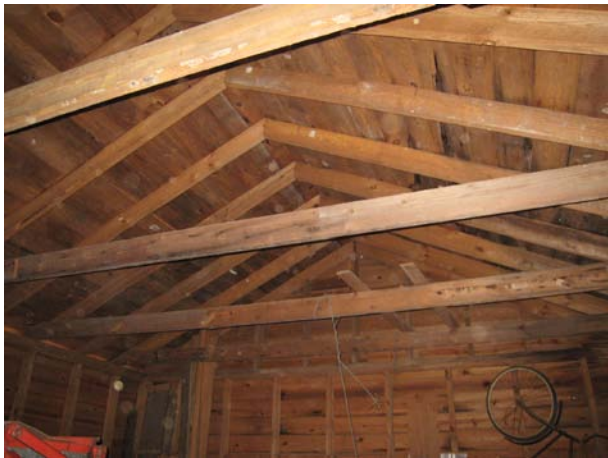
### 3. FARM SEAT GARAGE

**Foundation System:** concrete apron perimeter footing with a dirt floor  
Condition: fair  
Notes: cracks and plant growth

**Cladding System:** horizontal wood lap board  
Condition: fair  
Notes: some pull out

**Roof System:** joists and rafters with metal roofing  
Condition: fair  
Notes: one visible leak

1. Repair exterior siding, reinforce roof and patch, fix door: \$12,000

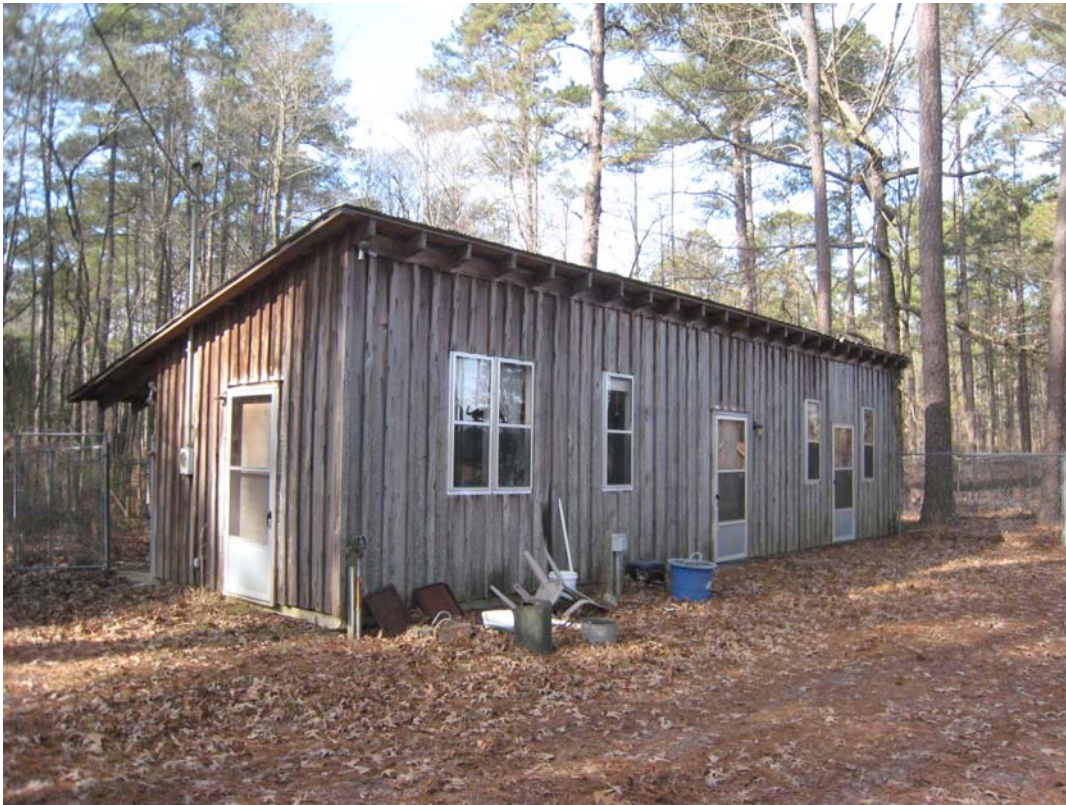
## 5. KENNEL

Notes: some cracking

Notes: areas of rot and pull out

**FCAP Recommendation:** demolish structure and grade site to safe condition

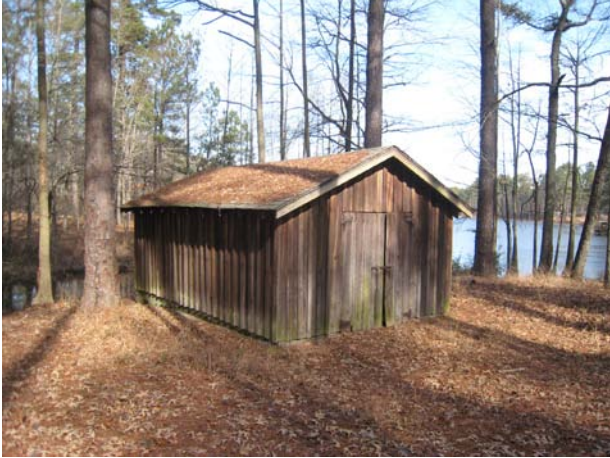
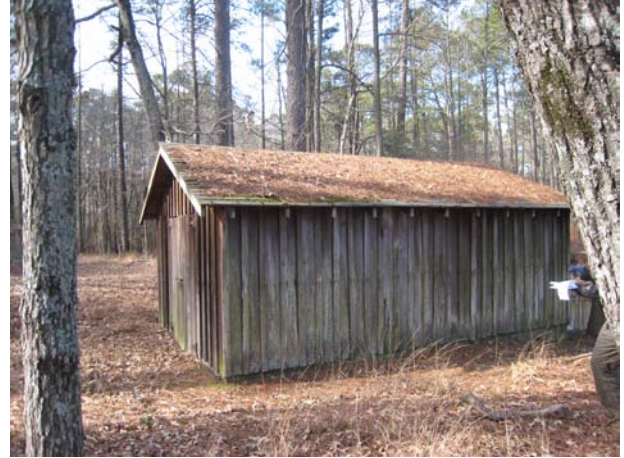
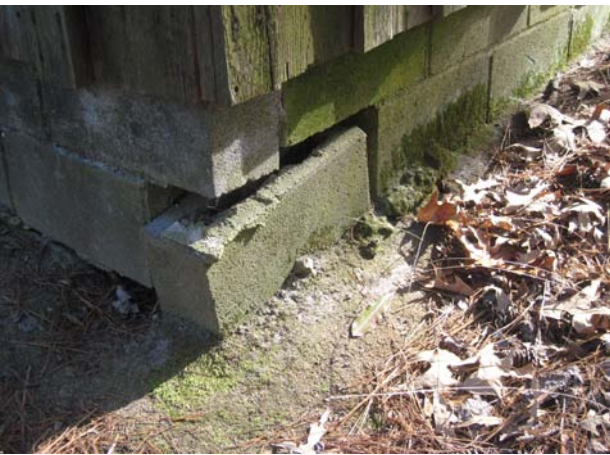
## 6. BOATHOUSE

**Foundation System:** cinder block on ground  
Condition: poor  
Notes: some blocks falling off (see image above)

1. Demolish and reclaim siding: \$4,000
2. Repair foundation, mold damage, and shingles for use as boat or general storage: \$3,000

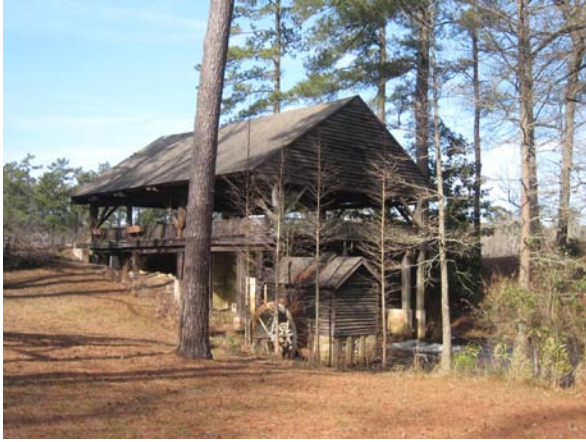
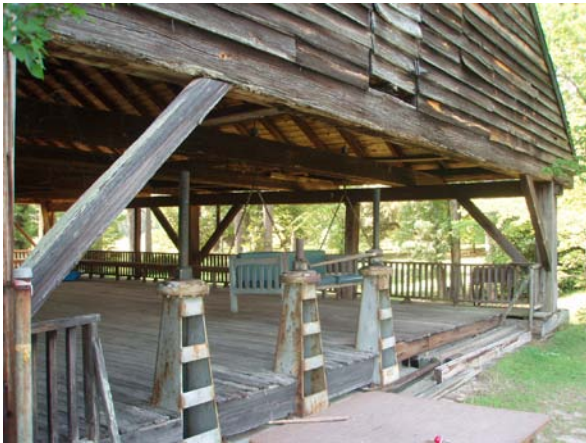
## 8,9. MILL PAVILION + DAM GATES

Notes: though structurally intact, the floor is unsafe for high occupancy

**FCAP Recommendation:** trim vegetation back; repair or replace deteriorated siding, flooring, railing, and structural members; re-grade perimeter to prevent erosion; upgrade and rewire electrical systems

1. Structural analysis for safety: \$2,000
2. Repair siding and roof, rebuild floor, trim vegetation, re-grade perimeter, upgrade electrical, make ADA accessible: \$110,000

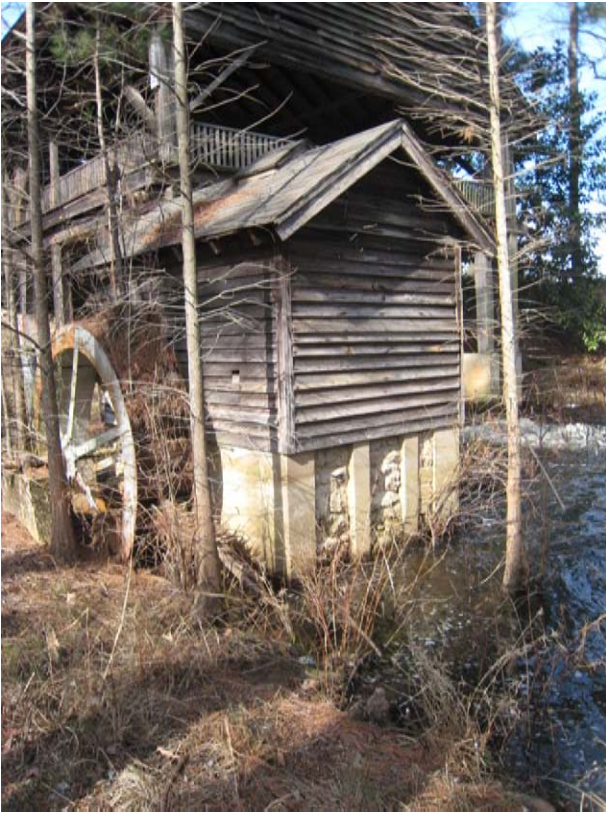
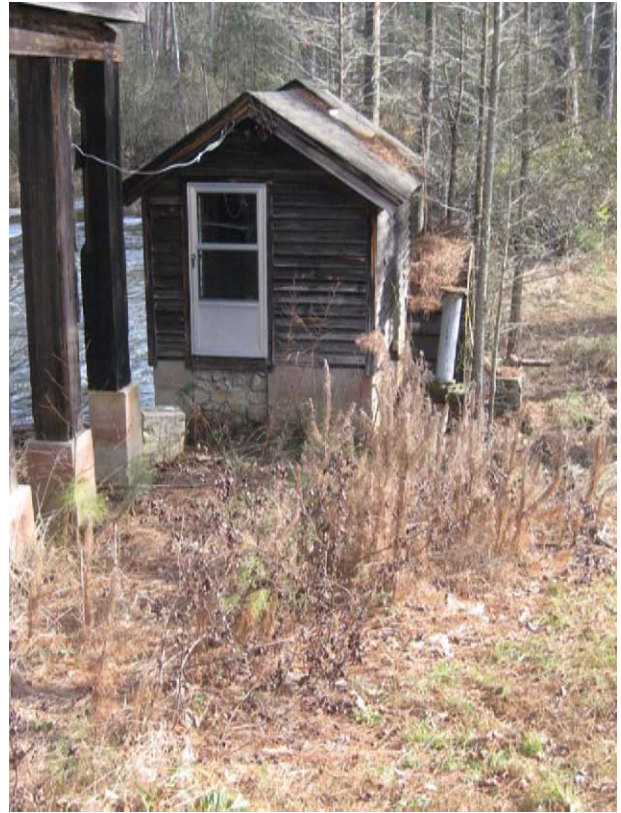
Notes: some debris and stains on roof

**FCAP Recommendation:** trim back vegetation; reattach  
or replace deteriorated siding and door; sandblast water-  
wheel and finish both wheel and housing

1. Trim vegetation, repair exterior, remove screen door,  
make secure, sandblast and refinish water-wheel (non-op-  
erational) \$15,000

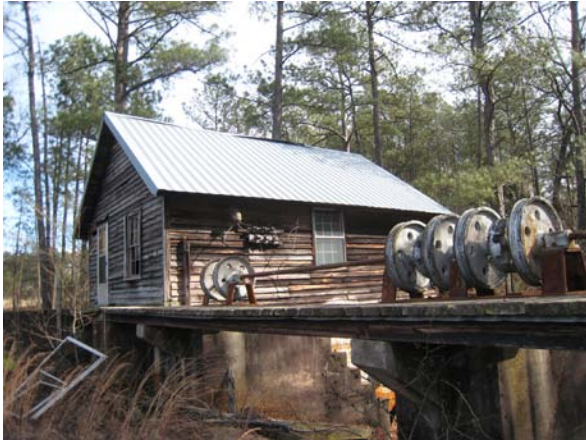
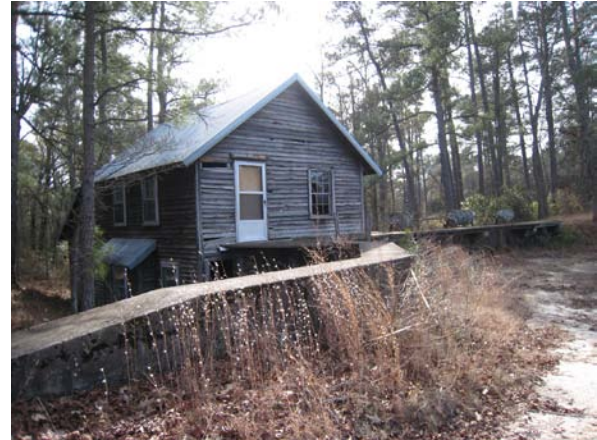
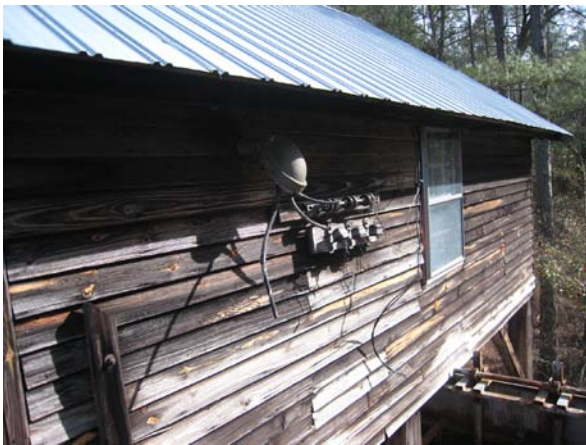
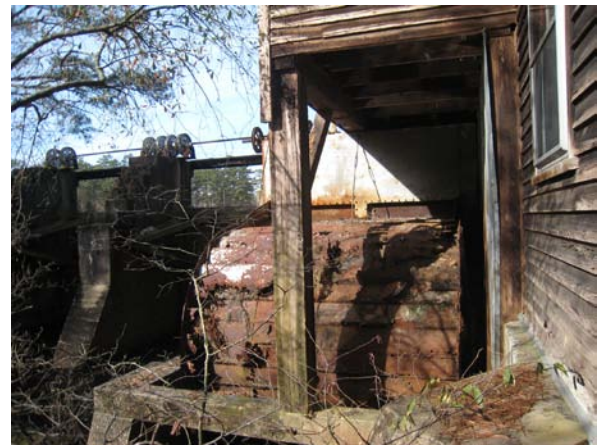
## 12. MILL HOUSE & GATES

**Foundation System:** poured concrete slab  
Condition: fair  
Notes: some cracking, chipping, moss growth on inside

**Cladding System:** horizontal wood lap board  
Condition: very poor  
Notes: holes, pull out, and moisture damage

**Roof System:** joists and rafters with metal roofing  
Condition: good  
Notes: new roof (unknown date), minor repairs needed

**FCAP Recommendation:** renovate structure to historical quality, fence area to prevent unauthorized entry

1. Repair exterior for exterior viewing only, non-functioning mill machinery, with ropes/fences to cordon off: \$100,000
2. Same as FCAP: Minimum of \$600,000 for historical quality renovation, still non functioning machinery.
3. Structural and historical review needed whether restored for exterior viewing only or for interior tours and operations: \$5,000. Please see note number 3 on page 2.

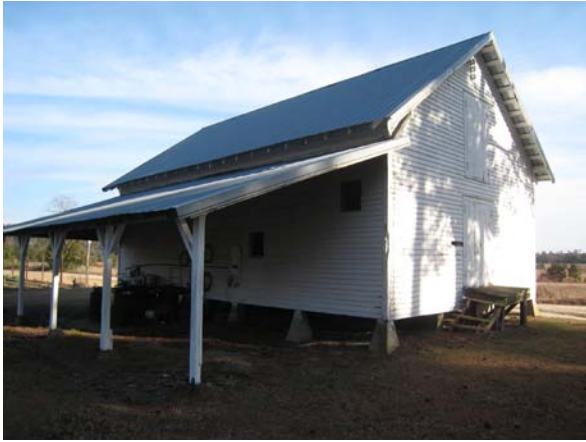
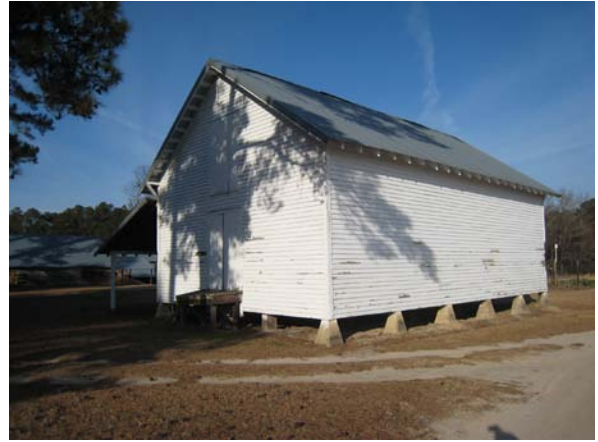
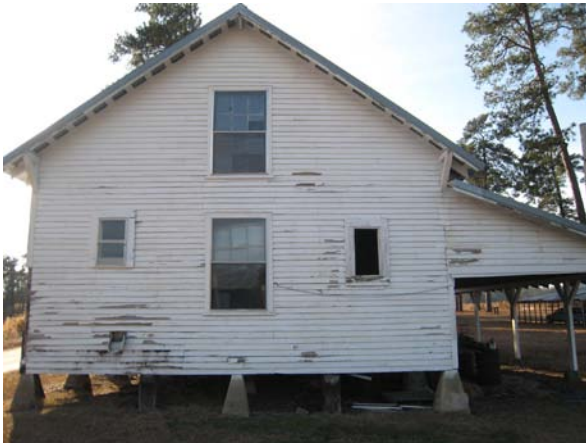
## 15. GRANARY

Notes: paint peeling, corner boards missing, openings without glass

**FCAP Recommendation:** replace front entry platform, reattach or replace deteriorated siding; scrape, sand, clean, and paint siding; reattach and seal metal roof

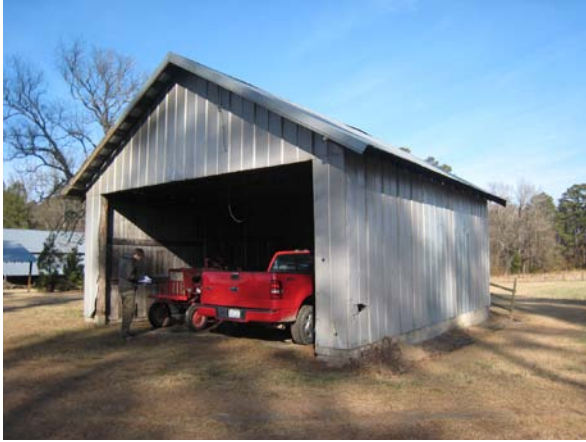
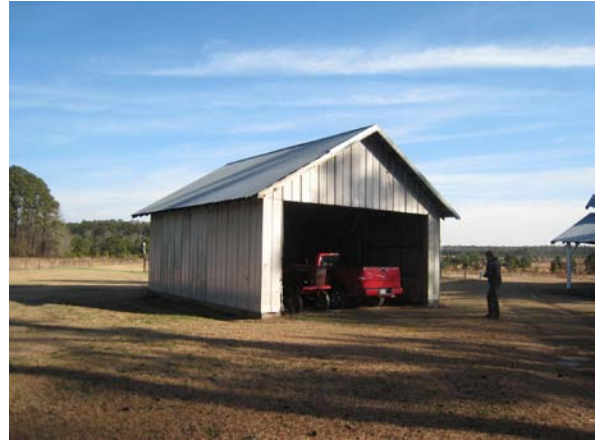
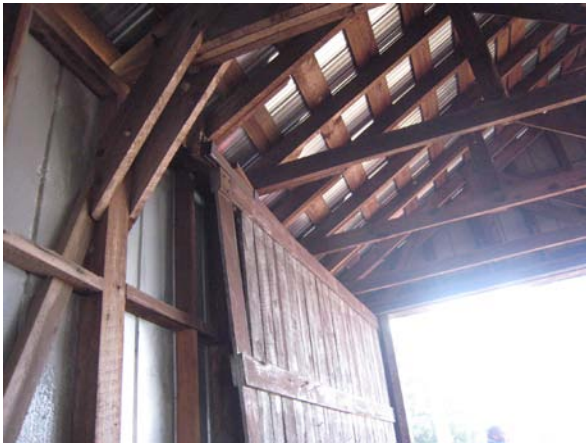
## 16. TRACTOR SHED

Notes: some cracking

Notes: small holes, window with missing pane

1. Repair siding as needed: \$1,000
2. Cracked existing concrete slab could be replaced: \$2,000.
3. Additional electrical service and fans so that building could be rented or used for environmental education classes: \$6,000

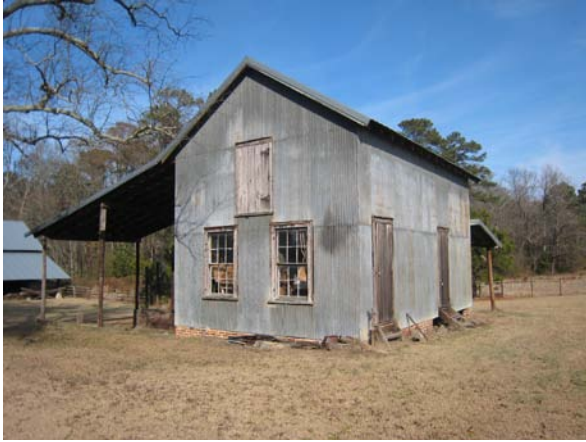
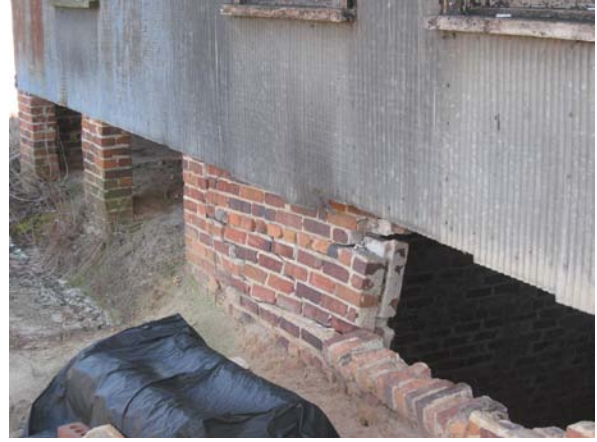
## 17. PACK HOUSE

**Foundation System:** masonry skirt and masonry pier  
Condition: fair to poor  
Notes: caving in at portions (upper right photo)

**Cladding System:** corrugated metal (vertical)  
Condition: fair to poor  
Notes: windows in poor condition, missing panes

**Roof System:** joists and rafters with metal roofing  
Condition: fair to poor  
Notes: east roof is giving way at corner

**FCAP Recommendation:** restore or replace entire structure

1. Repair exterior: \$15,000
2. Renovate interior, replace windows and doors: \$15,000
3. Add power, lighting, plumbing and HVAC if used for people: \$80,000

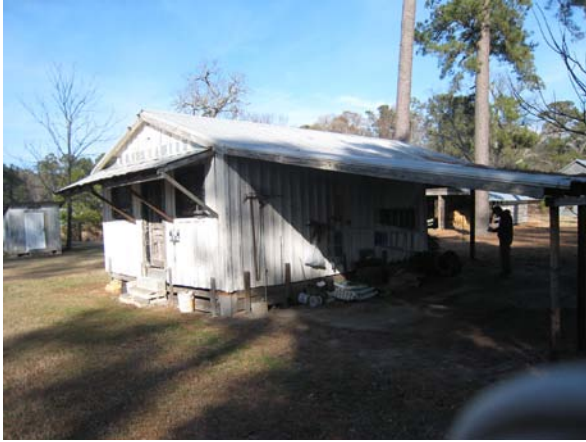
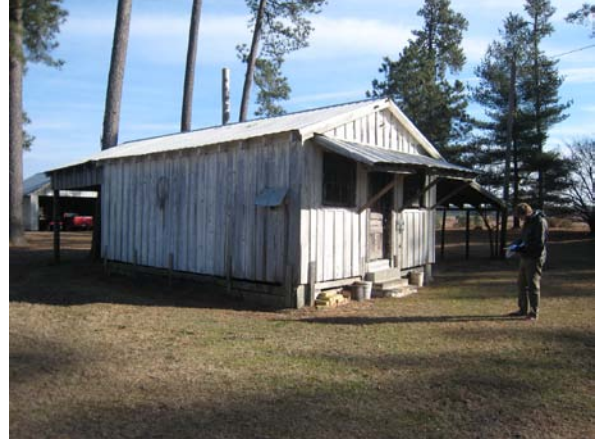
## 19. COMMISSARY

**Roof System:** rafters with metal roofing  
Condition: fair  
Notes: entry awning falling apart, shed rafters over spanned

1. Repair and repaint exterior, brace overhang, make secure: \$7,000
2. Repair interior and add fans (no HVAC) additional: \$3,000

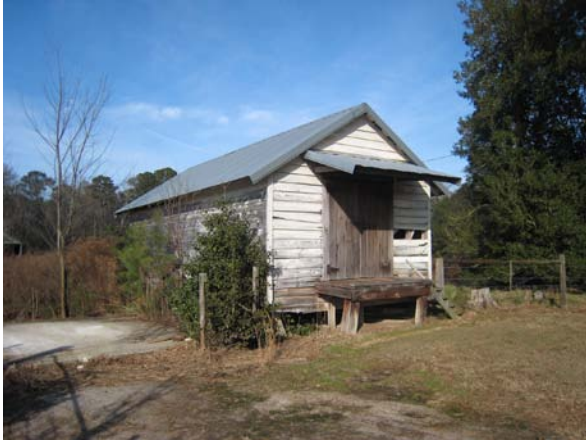
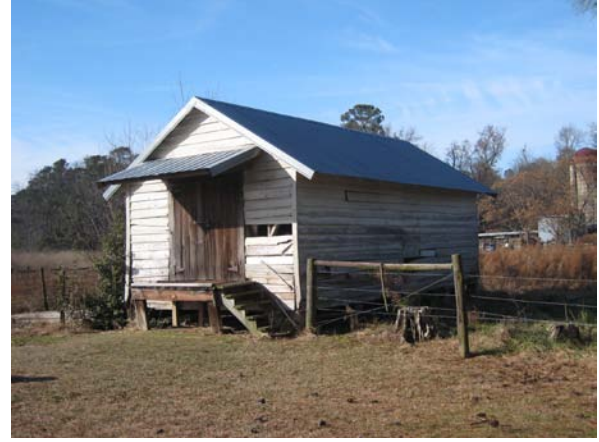
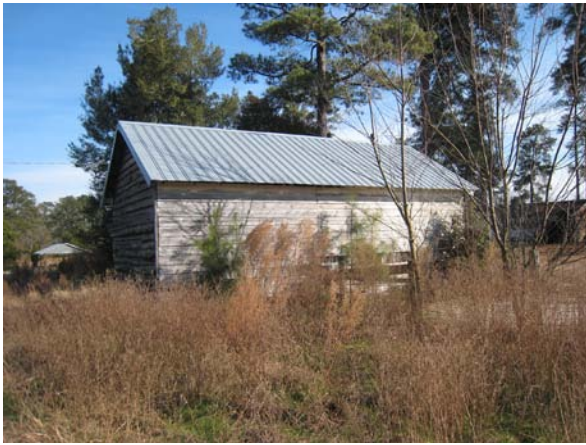
## 21. FERTILIZER HOUSE

**Cladding System:** horizontal wood lap board  
Condition: poor  
Notes: many pieces missing or rotten

**FCAP Recommendation:** replace front entry steps; re-attach or replace siding and doors; replace and seal metal roof where necessary; scrape, sand, clean, and repaint siding

1. Repair exterior, add siding, make secure: \$10,000

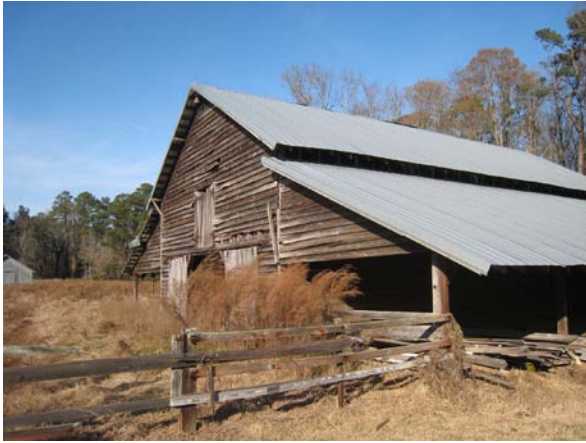
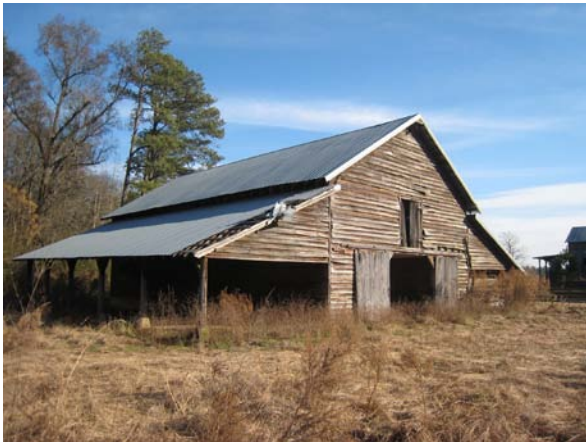
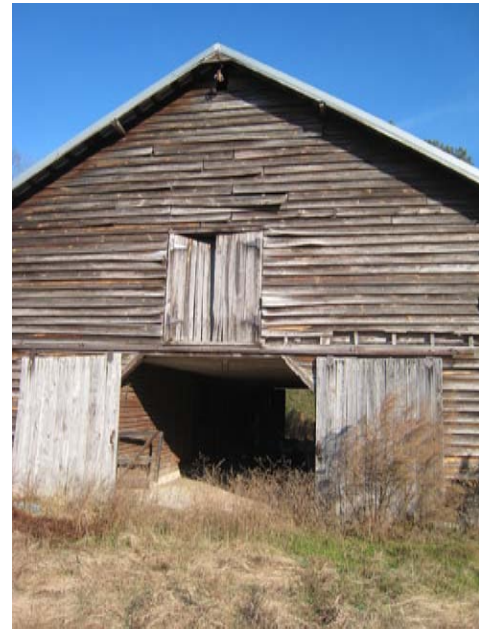
## 26. GREAT BARN

Notes: cracking (see photo #4), needs french drain along shed drip line (see photo #3)

Notes: some boards missing or pulling out

Notes: portions have significant damage (see photo #2)

**FCAP Recommendation:** rebuild structure, reuse current materials if possible; fence off structure to prevent unauthorized entry

1. Structural analysis: \$4,000
2. Repair exterior only: \$250,000
3. Open air rental pavilion with slab, power, lighting, and bathrooms: \$315,000
4. Welcome center with conditioned offices, meeting areas, displays, and restrooms (one flanking shed to remain open air with slab and perceable septic site assumed nearby): \$650,000

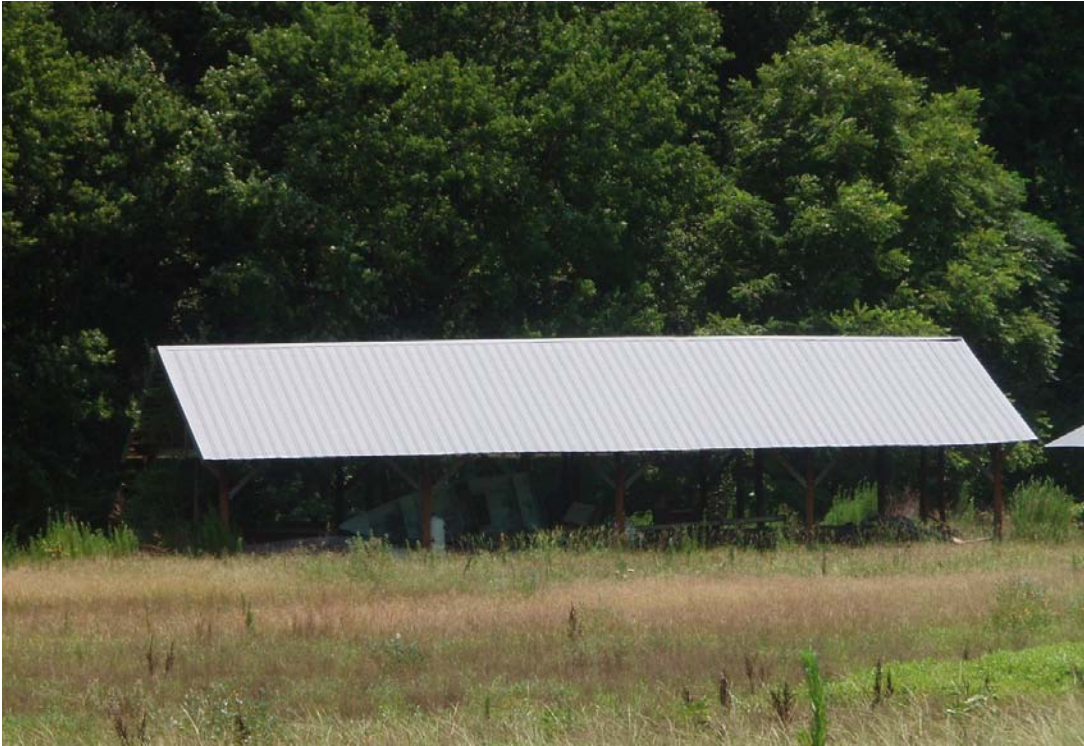
## 27. FEEDER SHED

**Foundation System:** concrete slab  
Condition: fair, some cracks, structurally good  
Notes:

**Structural System:** poles  
Condition: fair, structurally good  
Notes: one pole has come unattached but doesn't appear to effect stability at this date

1. Repair concrete slab and poles: \$6,000
2. Electrical and lighting updgades: \$10,000

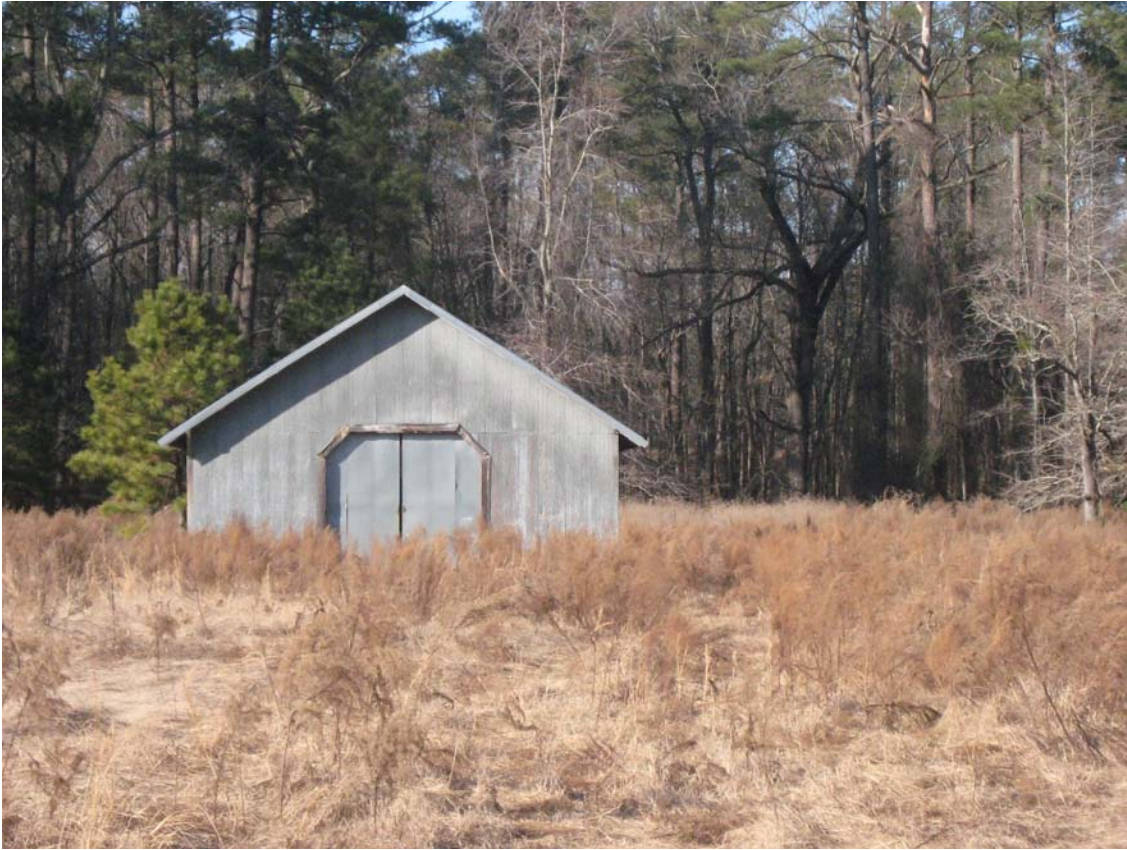
## 28. EQUIPMENT BARN

**Cladding System:** metal siding  
Condition: good  
Notes: a few small holes in metal siding, rear doors in major disrepair

**FCAP Recommendation:** replace damaged metal siding and roof panels; repair or replace rear doors; trim back foliage adjacent to structure

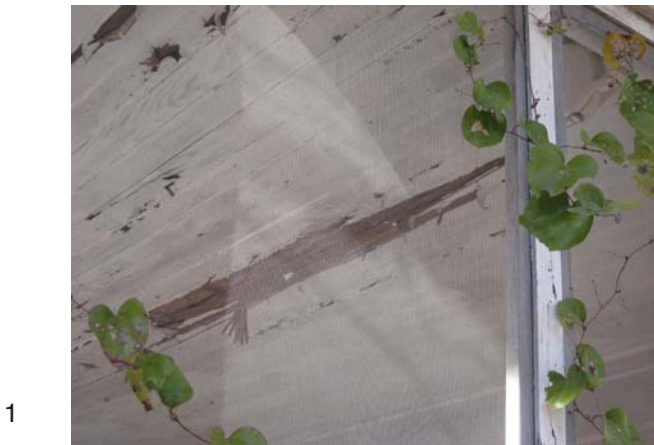
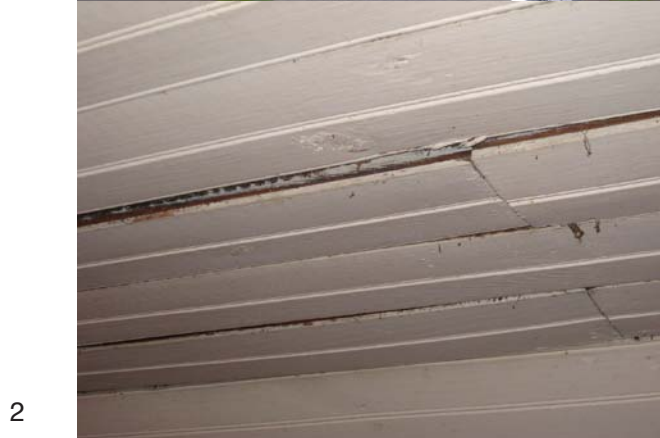
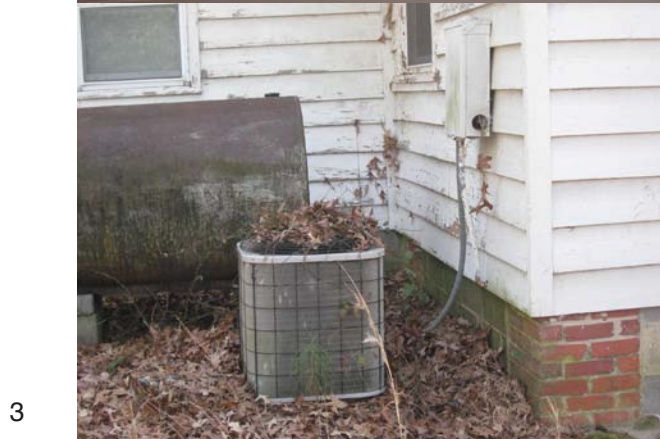
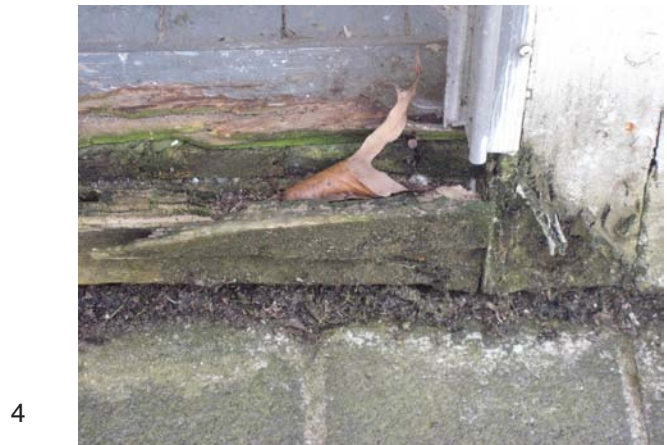
1. screen porch ceiling and growth
2. porch ceiling
3. AC unit

4. doorway rot

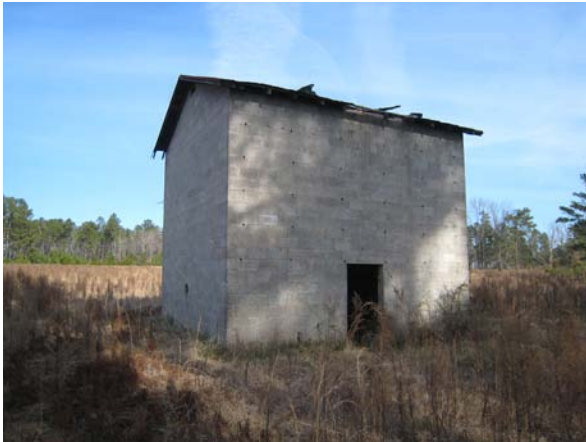
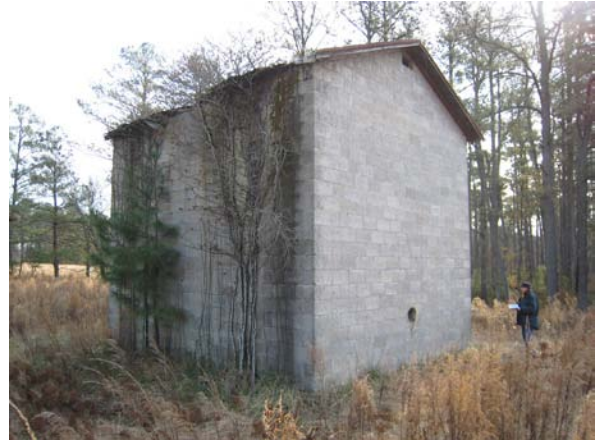
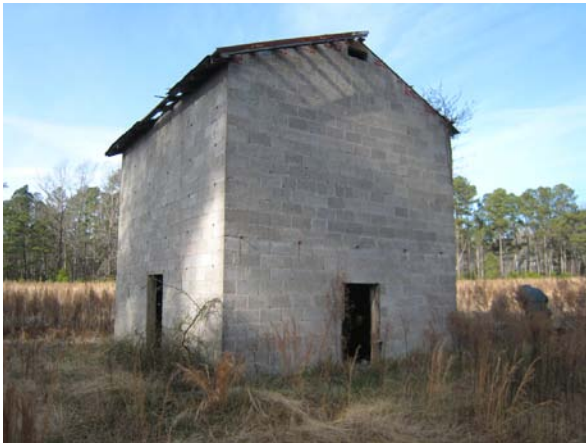
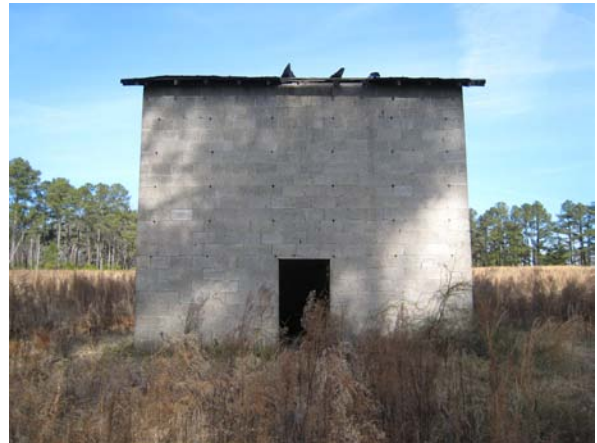
## 57. NORTH PASTURE TOBACCO BARN #1

1. exterior roof, missing boards
2. interior space, low entrance, drying boards
3. roof structure, rot and holes
